**ASSESSMENT REPORT:
INVENTORY OF HISTORIC ARTIFACTS FROM THE MISSION CONTROL CENTER,
CAPE CANAVERAL AIR FORCE STATION, BREVARD COUNTY, FLORIDA**

Prepared for:
John F. Kennedy Space Center
Environmental Management Branch
Kennedy Space Center, Florida

Prepared by:
Archaeological Consultants, Inc.
8110 Blaikie Court, Suite A
Sarasota, Florida 34240

May 2009

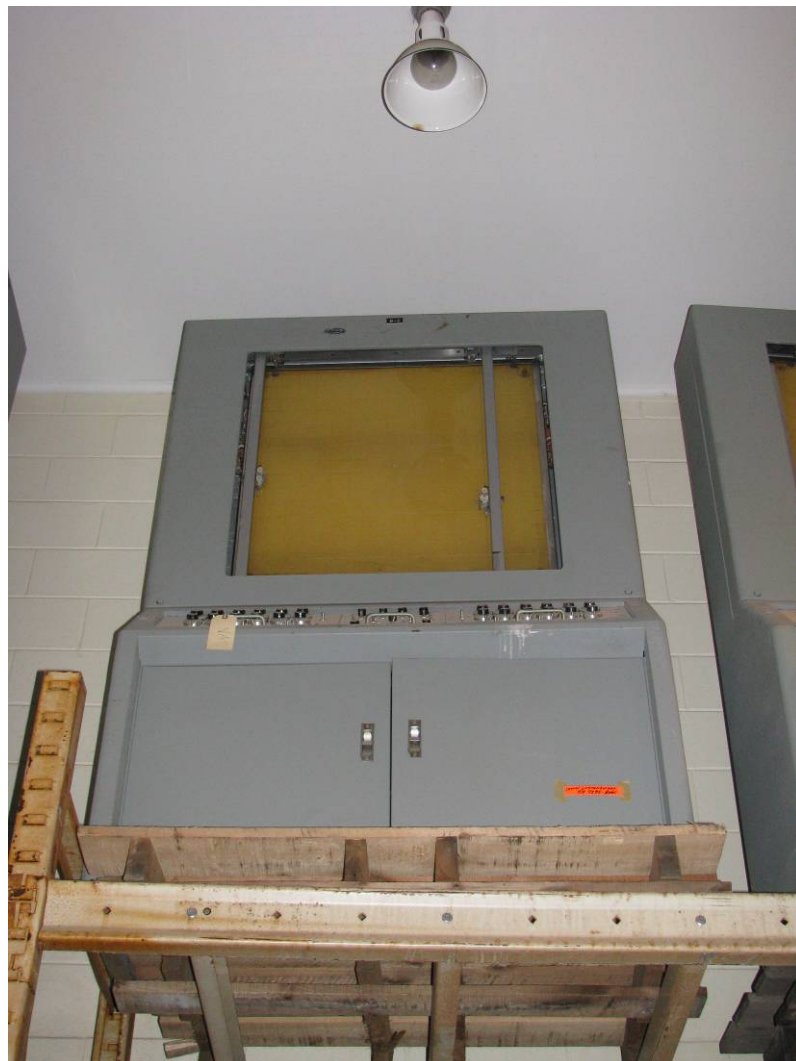
Three Plot boards (X-Y Recorders) (**Photos 46-48**) are located in the former Gemini Training Room (Room 211). All are Model 3010 X-Y Recorders manufactured by the Milgo Electronic Corporation (MEC) for IBM Corporation. Below each plotting board is a sloping front control panel. The third recorder (Photo 48), which could be closely examined, contains the power supply (Model 15-71A), Servo Amplifier (Model 15-31A), and Servo Supply (Model 15-72A). Historic photographs and other archival materials illustrate that four plot boards were located along the right hand side of the Flight Control Room during Project Mercury. A fifth unit was added during the Gemini program. Three of the original units, MEC X-Y Recorder Model 3010, are on display in the ESE exhibit.

Photo 46. X-Y Recorder B-2 located in the Gemini Training Room, looking west
(Source: ACI Photo 49, March 2009).

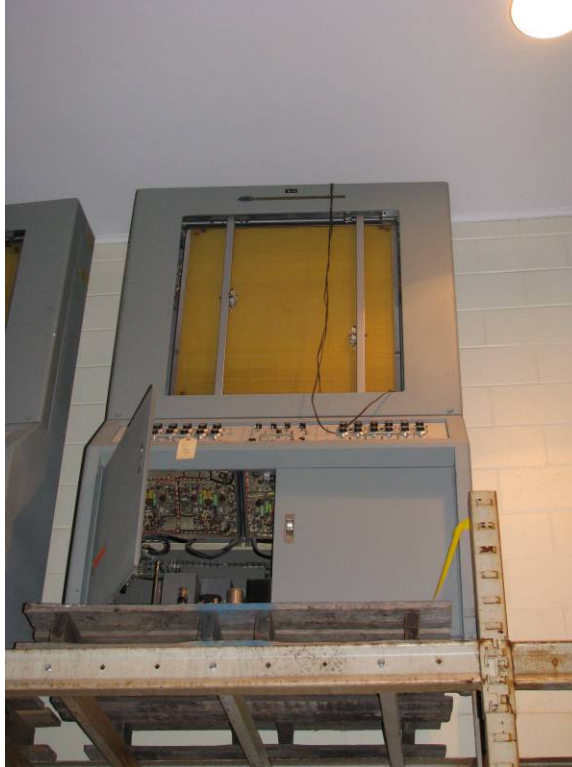
Photo 47. X-Y Recorder B-4 located in the Gemini Training Room, looking west
(Source: ACI Photo 50, March 2009).

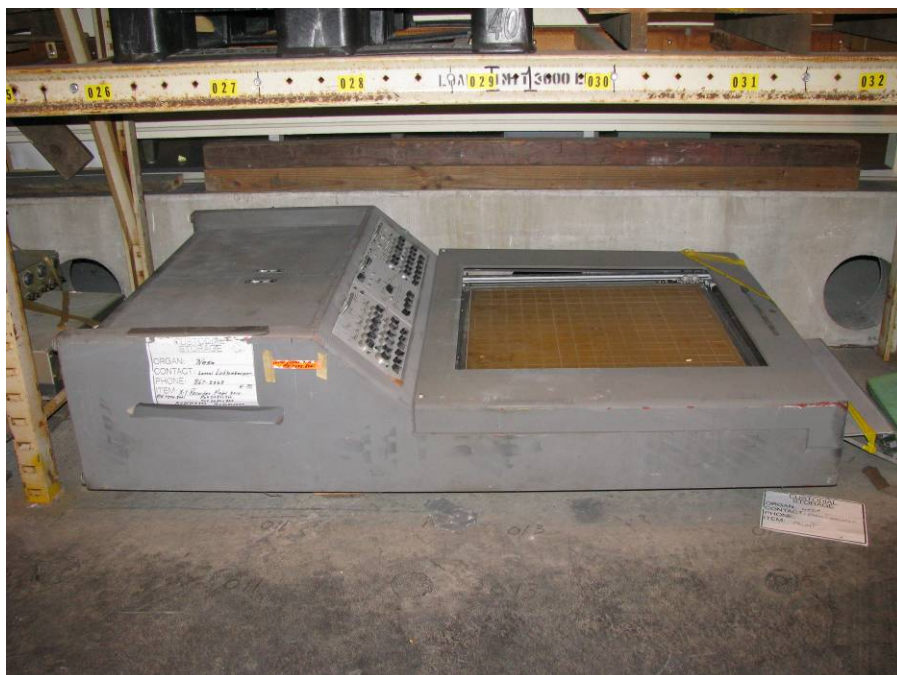
Photo 48. Third X-Y Recorder located in the Gemini Training Room
(Source: ACI Photo 52, March 2009).

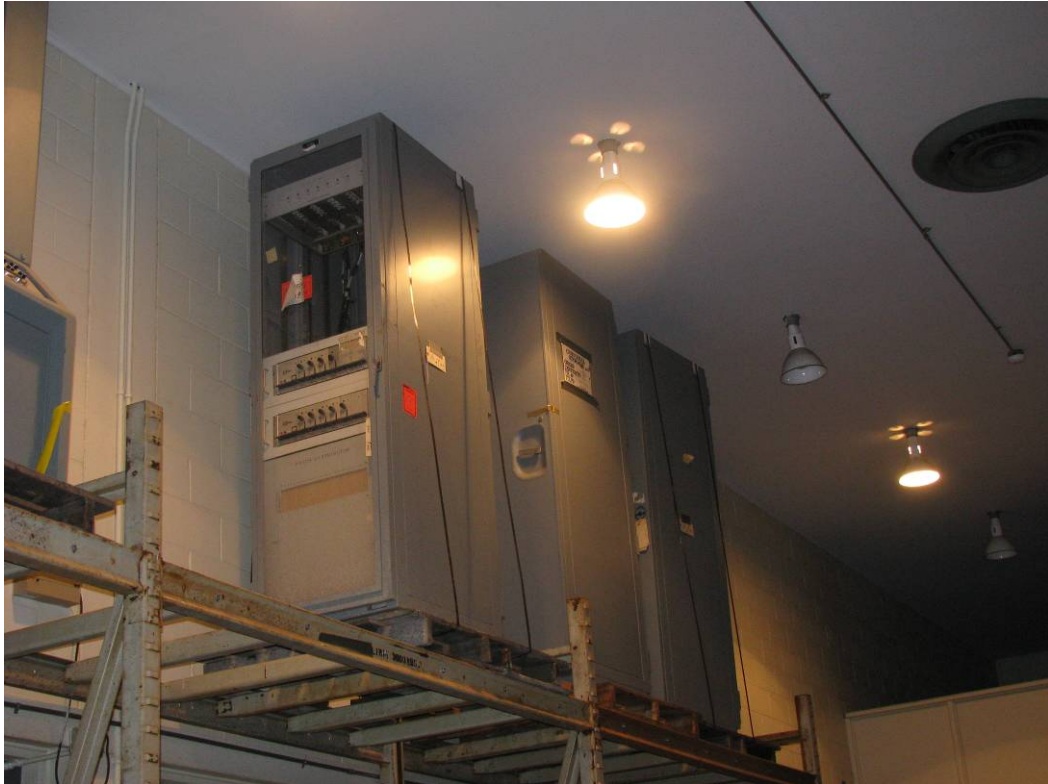
Three upright consoles (**Photo 49**) are located in the Gemini Training Room. Identification tags were not visible. It is not known whether these are associated with either the Mercury or Gemini programs, and the function of each is unknown. The consoles at the left and right are each labeled “Patch Distributor;” the front of the middle console was not observable.

Photo 49. Consoles (of unknown function) in the Gemini Training Room
(Source: ACI Photo 140, March 2009).

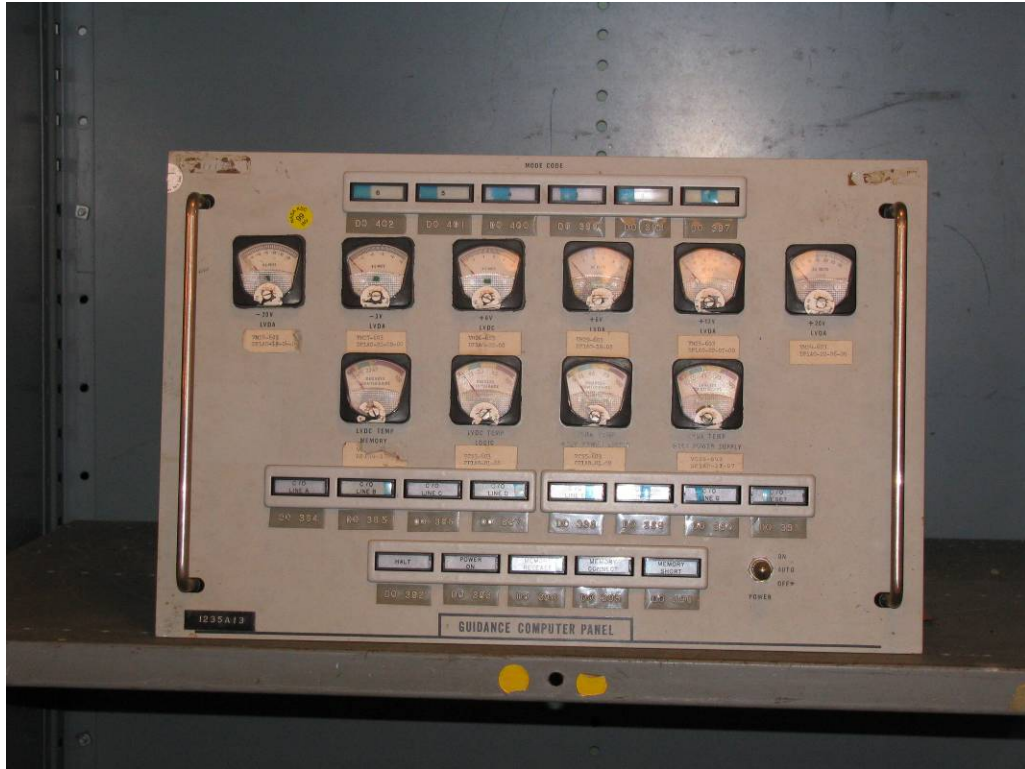
Photo 51. Guidance Computer Panel located in the Telemetry & Capsule Communications
(Source: ACI Photo 144, March 2009).

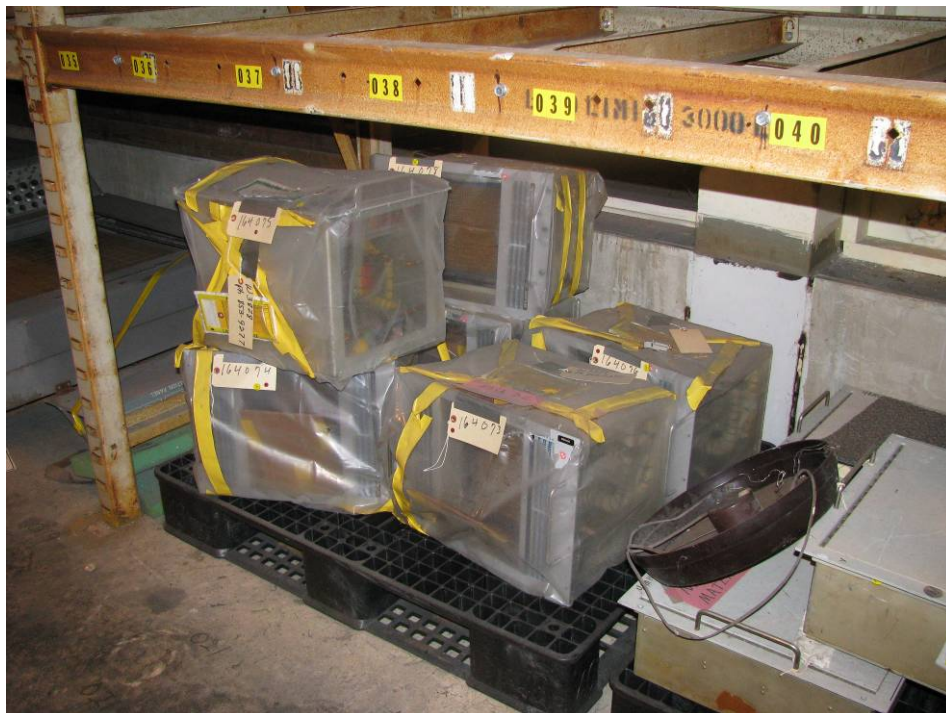
Photo 52. Console components in the Gemini Training Room
(Source: ACI Photo 139, March 2009).
